ORBITER GLOBAL POSITIONING SYSTEM DESIGN
AND KU-BAND PROBLEM INVESTIGATIONS
EXHIBIT B - REVISION 1

TR-0783-0980

INTEROFFICE MEMORANDUM
TM-1080-1182

Subject: Shuttle Ku-Band Forward Link Costas Demodulator Lock Indicator
Blinking Problem

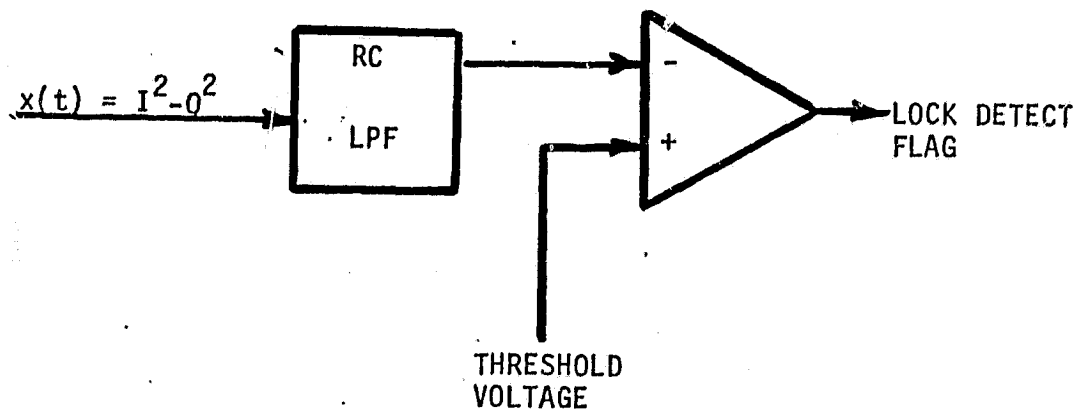
Figure 1. Costas Loop Lock Detector.

It therefore appears that the blinking problem is a consequence of the desire to use the tracking threshold to indicate false side-lobe illumination condition. Apparently, the threshold was set to threshold at the highest expected side-lobe power level. This is different from the normal practice of employing the lock indicator to monitor excessive cycle slipping or drop-lock. The receiver was implemented in such a way that, unfortunately, when the tracking threshold is crossed, the receiver goes to sweep acquisition. This causes the blinking.

The signal $x(t)$ input to the low pass filter is of the form $I^2 - Q^2$, where $I(t)$ and $Q(t)$ are respectively output of the in-phase and quadrature arm filters of the Costas Loop, Fig. 1. During acquisition the signals $I(t)$ and $Q(t)$ is of the form

A simple solution to this problem is to use the present threshold detector for conventional out-of-lock indication but then add another threshold detector for false side-lobe lock monitoring.

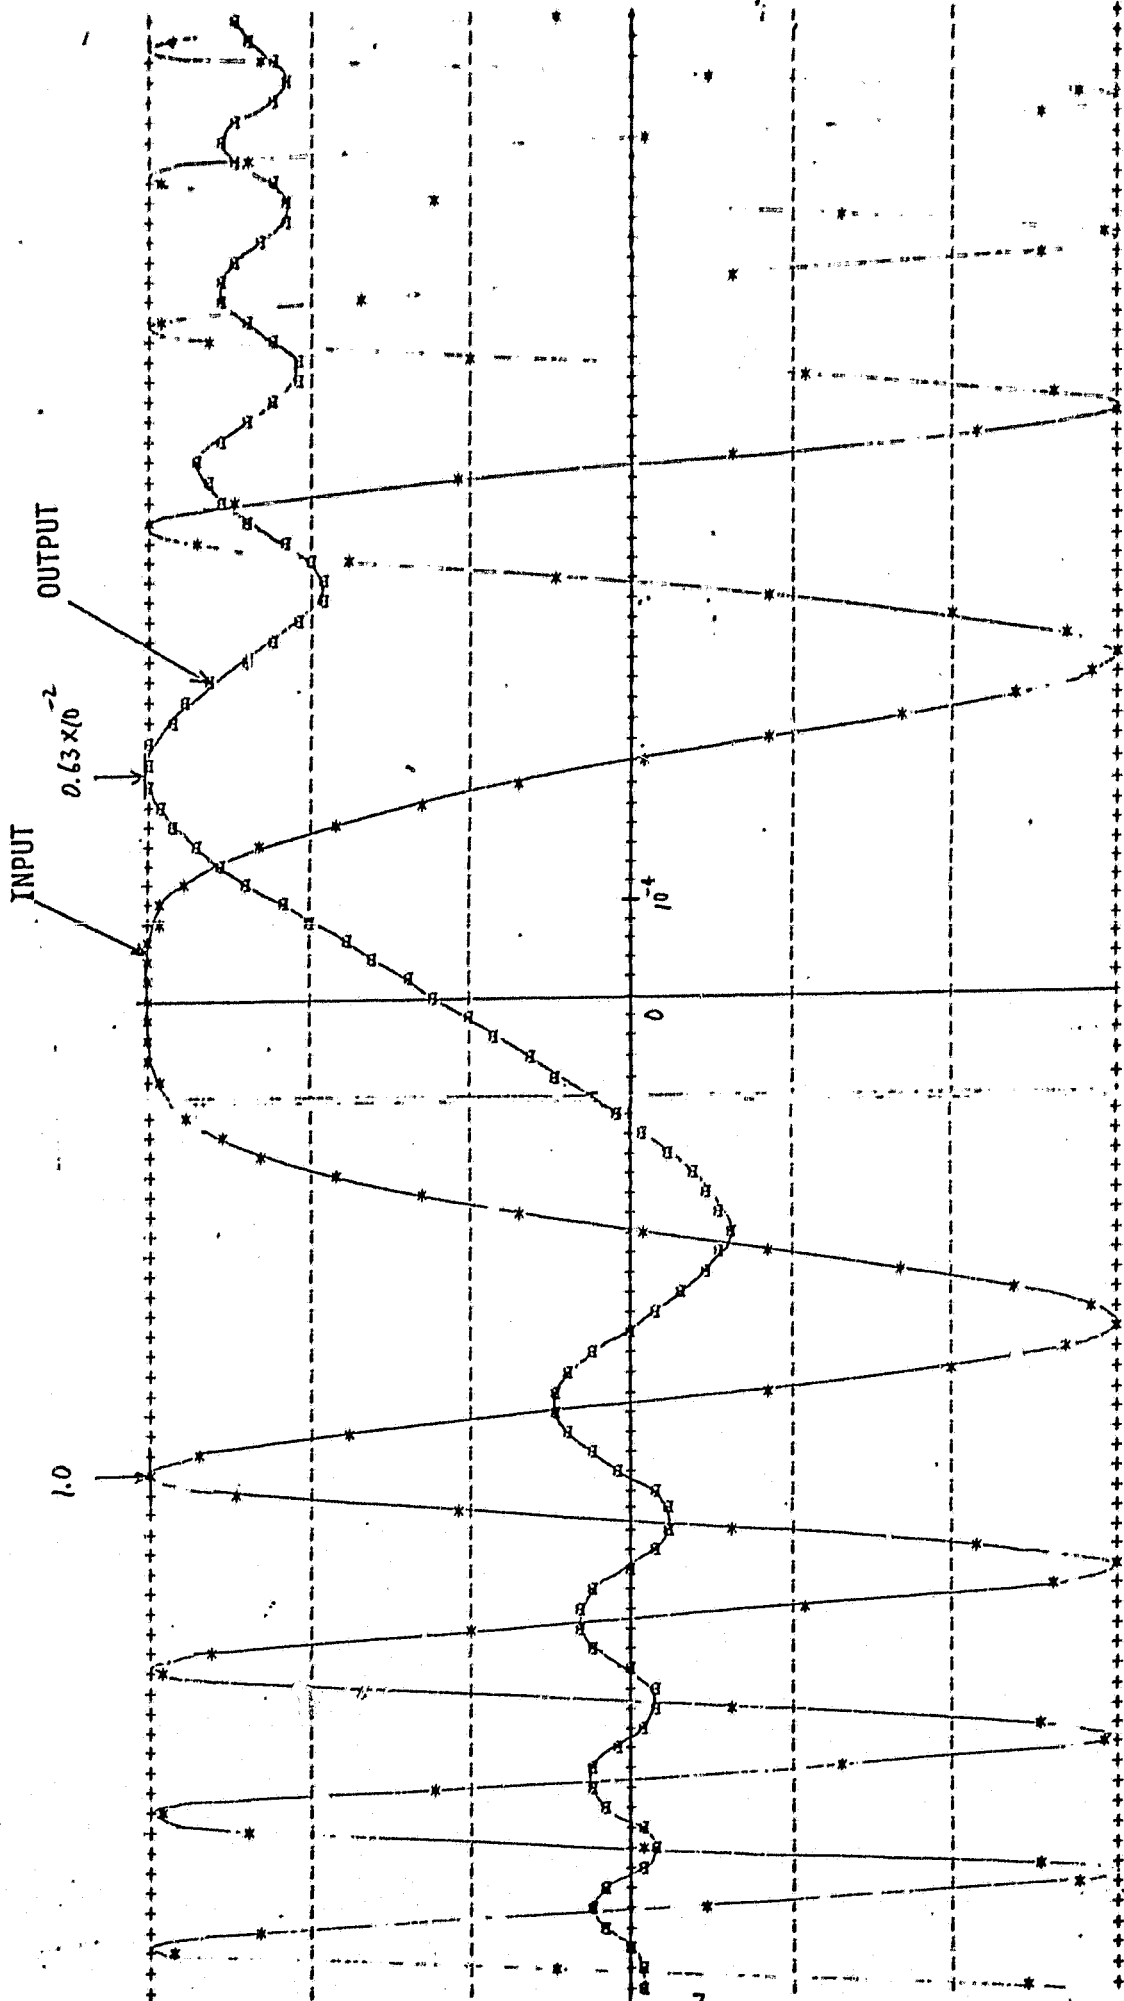
Figure 2. Lock Detector Response for $\phi = 0$.

Figs. 2 to 4 are simulations output for $\phi = 0, \pi/4$ and $\pi/2$ radians. For all cases, the output signal peak is in the order of $6 \times 10^{-3} A$. This signal amplitude is much less than the tracking threshold and will not cause any on-off oscillation of the lock detector flag. Therefore, it appears that the on-off oscillation is due to the fluctuation of tracking signal about the tracking threshold.
